ST ODULPH'S CHURCH, CORNWALL: STRUCK BY LIGHTNING

ST ODULPH'S CHURCH

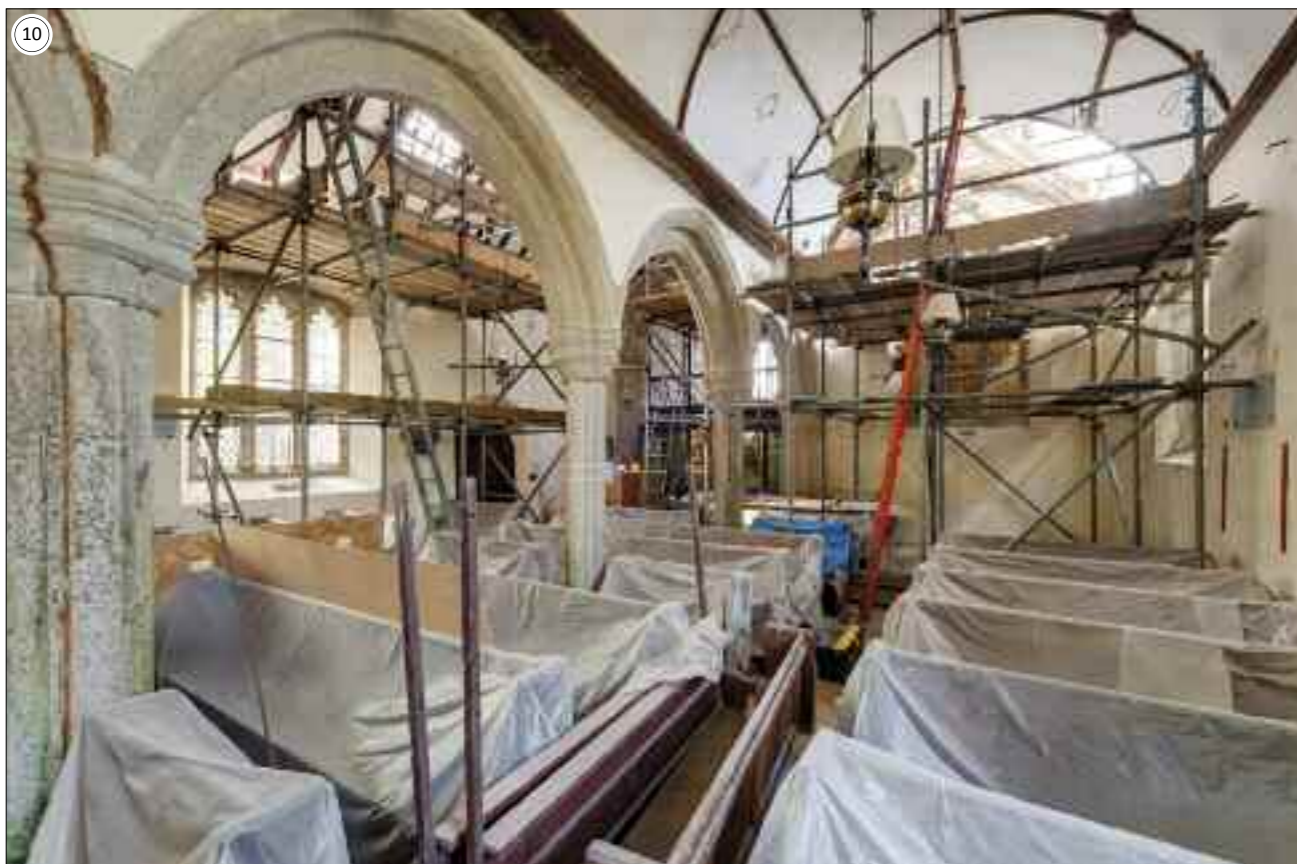
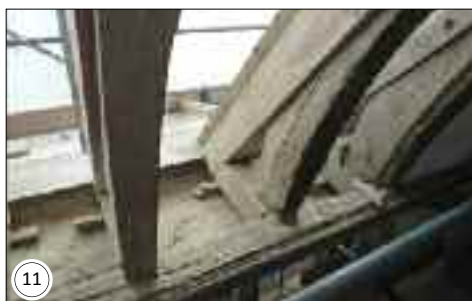
- Site scaffolding completed – external and internal.
- After discounting other options (including cranes and helicopters) steel beams, together with specialist heavy joist and hoisting kit, arrive on-site and enable the complete removal of fallen stones from the tower and nave roof and interior.
- Close inspection of the tower parapet and pinnacles by architects and structural engineer. The south-eastern tower pinnacle had been struck by flying debris which had caused its upper section to move. Scorching and cracking to the pinnacle

cross now becomes apparent, and the extent of the damage to the lead tower roof coverings can now be seen clearly.

- Westcountry Stonemasons dismantle the top two-thirds of the shifted south-east pinnacle in-situ, before rebuilding and repairing.
- Masonry from the destroyed north-east pinnacle is put together in the stonemason's yard, enabling a full ground-level assessment of the required restoration and remedial works. No mortar is used at this stage, instead it is dry-built in sections; a four-and-a-half foot high 3D jigsaw.
